## 2026 Annual Landfill Inspection

*Osage Power Plant Legacy Surface Impoundment*

Prepared for:  
Black Hills Power

Prepared by:  
Barr Engineering Co.

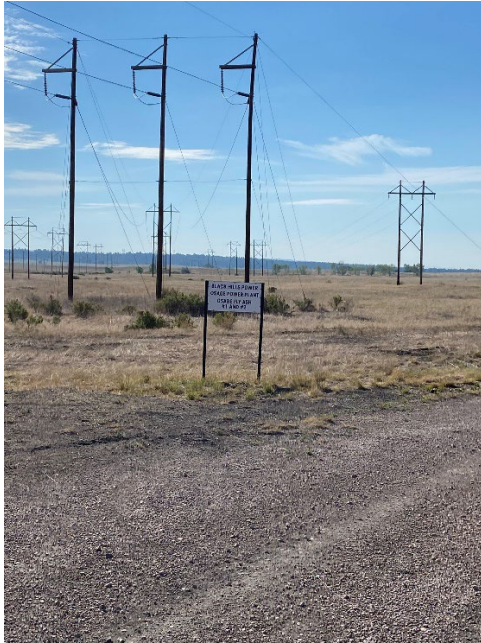
**Subject:** Sign located at entrance to facility

**Comments:** Access is controlled by a locking gate, fences, and natural barriers.

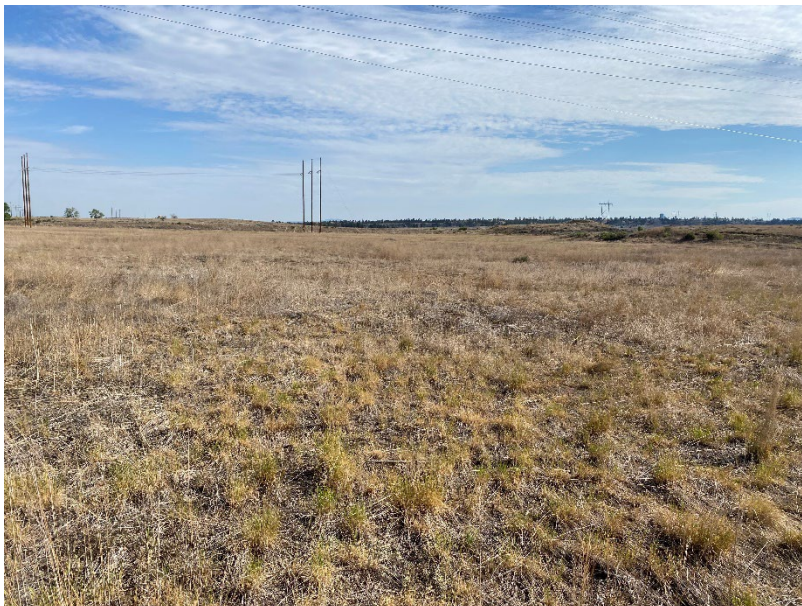
| Item | Structural Weakness Description | Visibly Present/Deficient (Yes/No) | Notes |
|---|---|---|---|
| 9 | Excessive or lacking vegetative cover | No | Vegetation appeared uniformly well-established and well-maintained on the cover system and perimeter embankments. |

**Subject:** Vegetation on cover system

**Comments:** Vegetation across the site appears uniform and in good condition for the season.

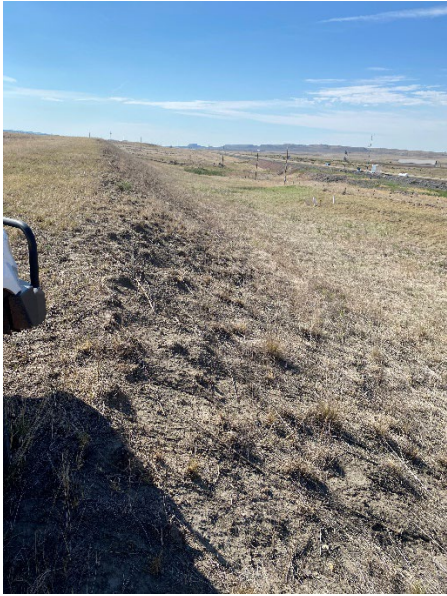
**Subject:** View along western edge of impoundment

**Comments:** Western berm has highest elevation above native ground surface and appears to be in good condition.

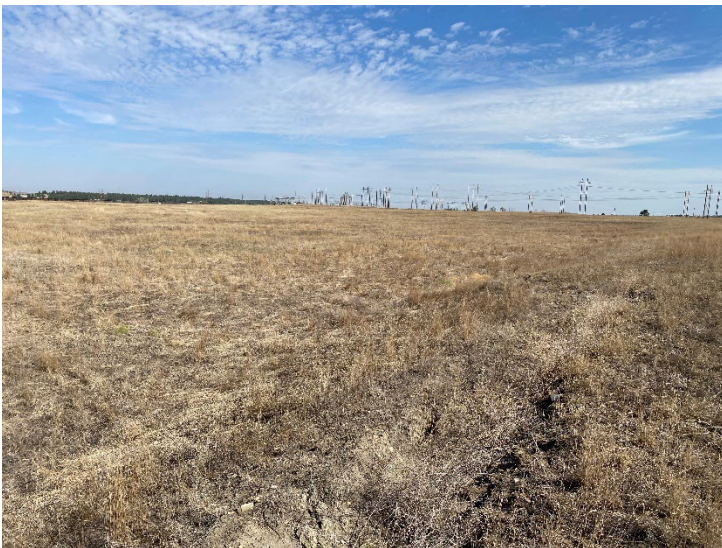
| Item | Structural Weakness Description | Visibly Present/Deficient (Yes/No) | Notes |
|---|---|---|---|
| 3 | Transverse, longitudinal, and desiccation cracking | Yes | An isolated interior area showed some cracking, possibly due to differential settlement. |

**Subject:** Isolated area with crack in cover system

**Comments:** Crack possibly caused by differential settlement. Appears to be in area where CCR (on left side of photo) abuts an interior berm (higher area to right).

An isolated area of the cover system showed minor cracking, possibly due to differential settlement. The cracking was observed in the interior of the surface impoundment and poses no threat to the structural stability of the closed unit. BHP should consider repairing the crack when convenient. No other corrective measures are recommended for the Osage Legacy Surface Impoundment.
